# **TALLAHASSEE MASTER PLAN – SURFACE WATER (TMaPS): VOLUME 3**

## **LAKE MUNSON BASIN**

Project Number: FW7714

July 2025

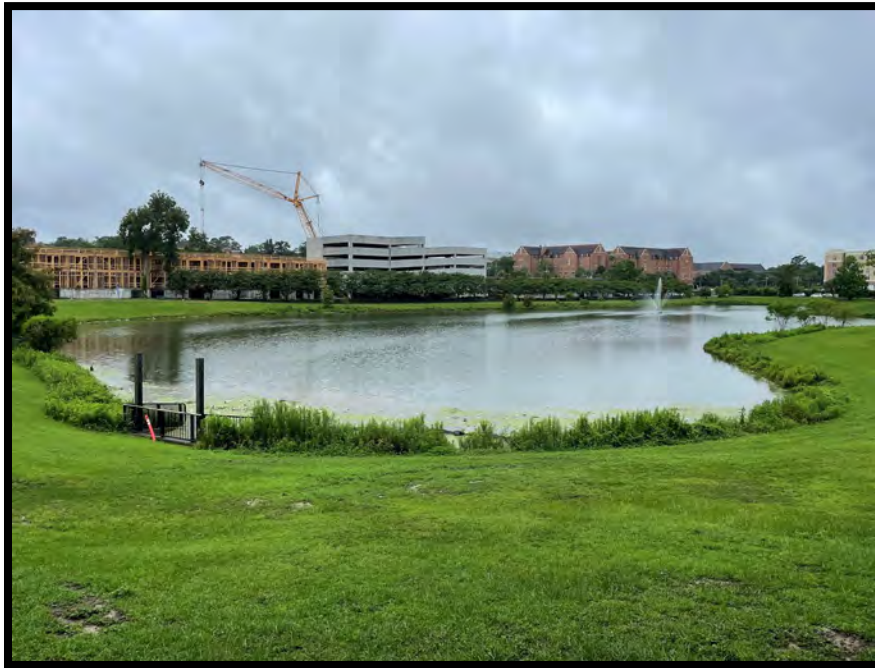
**Photo 3-11: Carter-Howell-Strong Wet Detention Pond**

Due to its highly urbanized nature, the Central Drainage Ditch, and the historic St. Augustine Branch which flows into the Central Ditch, contain a number of larger regional facilities. The Carter-Howell-Strong Pond (**Photo 3-11**), located in the upper end of the Central Ditch is a 5-acre wet detention facility that receives drainage from portions of FSU and surrounding residential areas. Lake Elberta (**Photo 3-12**) is a 17-acre wet detention facility at the confluence of the Central and St. Augustine Branch. A series of treatment facilities is located along the historic St. Augustine Branch. These include the Cascade Park stormwater treatment facilities

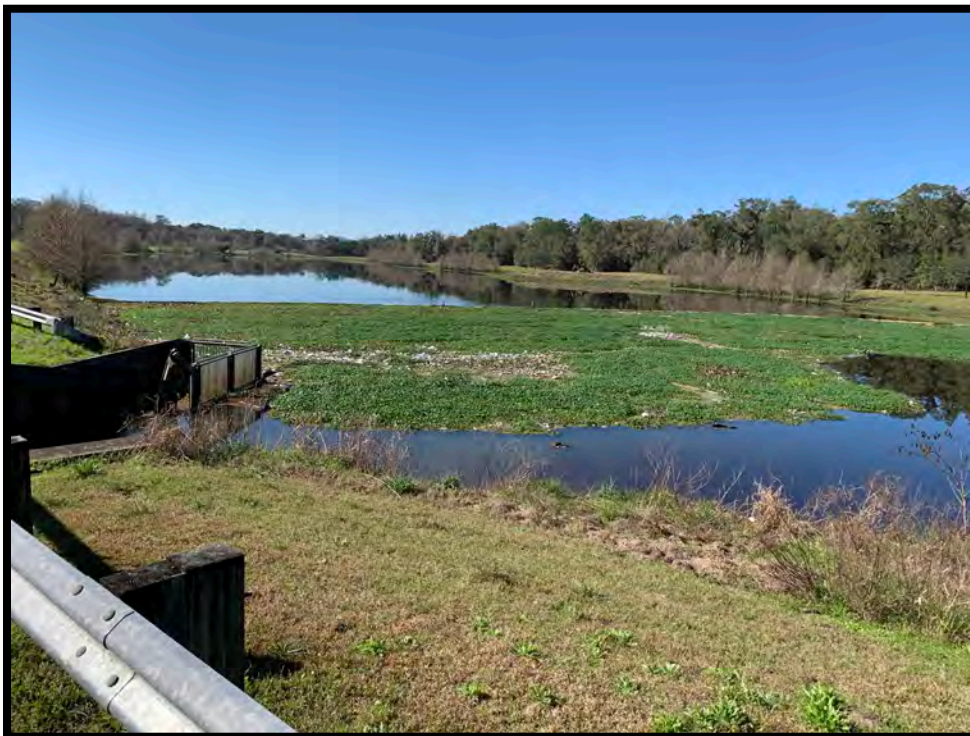
**Photo 3-18: Lake Henrietta SWMF Regional Treatment Pond, Middle and South Sections Facing South**

The largest stormwater facility within the Lake Munson basin is the Lake Henrietta SWMF, which was constructed in 2000 and is located at the confluence of Munson Slough and the East Drainage Ditch. Lake Henrietta was historically a wetland system that was altered through the construction of a mosquito control ditch and berm, and ongoing sedimentation and pollutant discharge from Munson Slough. As part of the Leon County Lake Munson restoration, the altered wetland system was converted to a 25-acre wet detention treatment facility with trash traps to reduce sediments, slow runoff, and reduce trash before water enters the restored and stabilized channel north of Lake Munson (**Photo 3-17** and **Photo 3-18**).
