3.5 Bradford Chain of Lakes

3.5.1 Overview and History

Tallahassee Master Plan - Surface
Water (TMaPS)

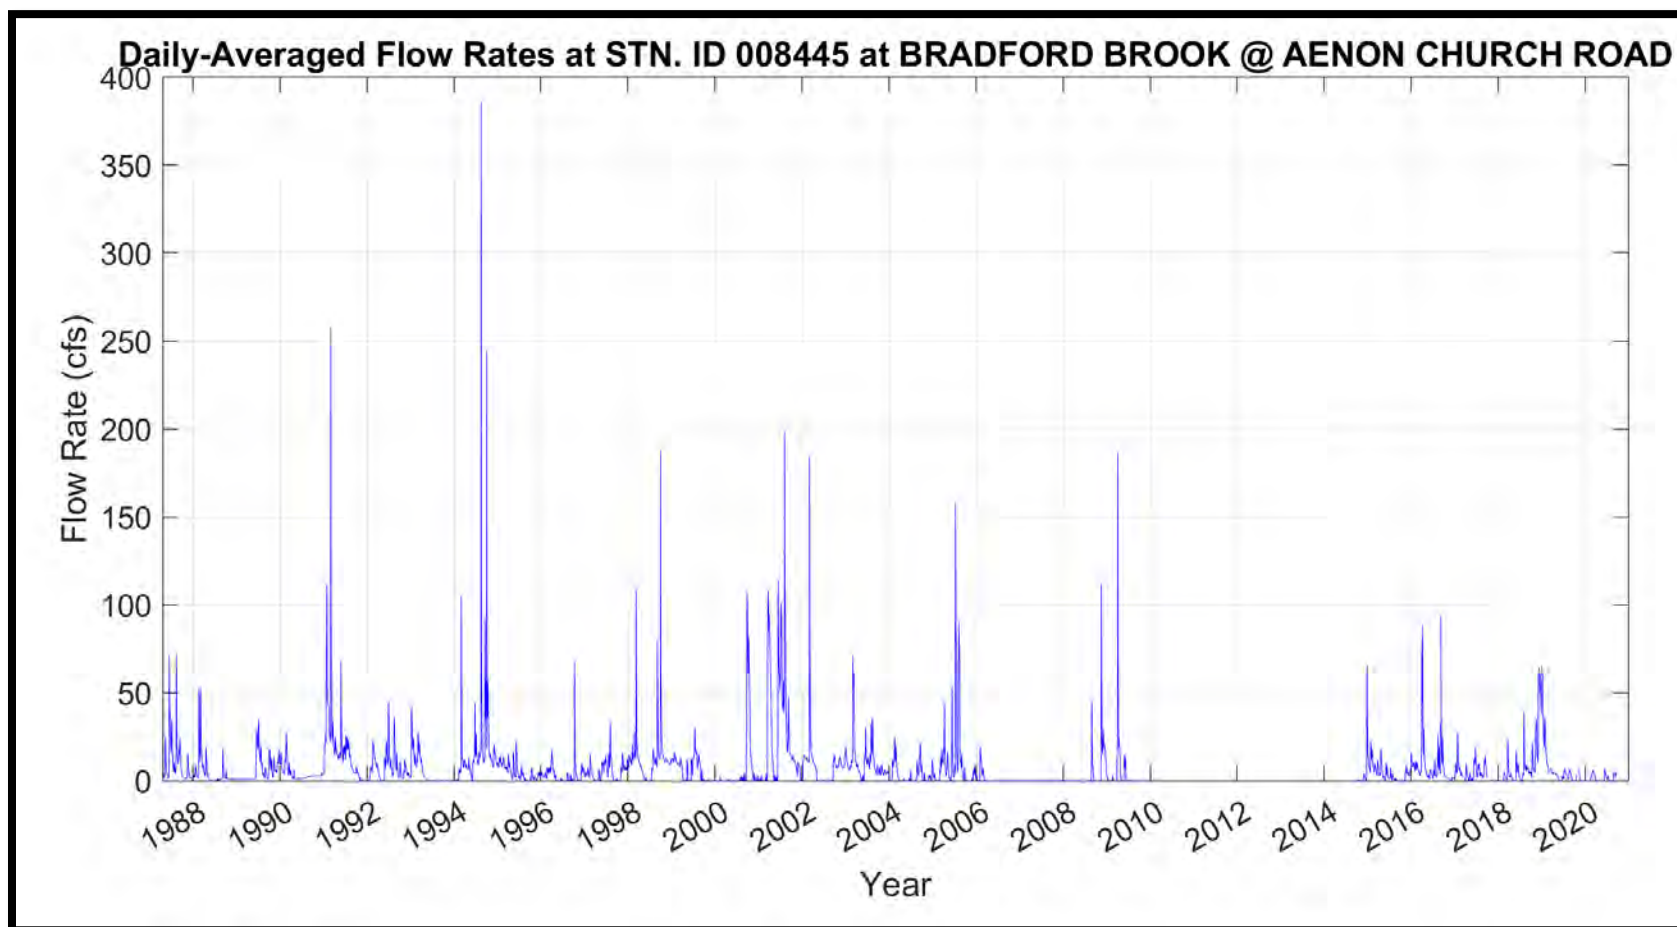
Figure 3-52: Daily Average Flow on Bradford Brook at Aenon Church Road (Station 008445) (1988 to 2020)

A flow measurement station is located upstream of Cascade Lake where Bradford Brook crosses Aenon Church Road (**Exhibit 3-6**). These data reflect the flow out of the Apalachicola National Forest. **Figure 3-52** presents a plot of the daily average flows from 1988 through 2020. In comparison to flows from Munson Slough and the West Ditch, these flows show a much less flashy extended baseflow driven signal, which represents more natural conditions. Peak flows are as high as 400 cfs, with typical peaks ranging between 100 and 200 cfs, and are of the same order of magnitude as stations in other more urbanized areas with significantly smaller drainage areas (**Section 3.4.3.6** and **Section 3.6.3.5**).
