# TALLAHASSEE MASTER PLAN – SURFACE WATER (TMaPS): VOLUME 4

## VOLUME 4 LAKE JACKSON BASIN

Project Number: FW7714

City Project/CIP No. 265

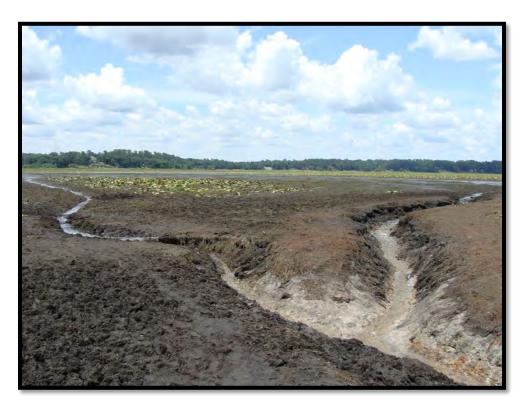
Photo 4-1: Flows Draining from Lake Jackson to Porter Sink (June 14, 2021)

The lake has two primary sinkholes within its boundary, Lime Sink and Porter Sink (**Exhibit 4-1**). Presently, the degree of outflow through the sinks to the Floridan Aquifer is not fully understood. Historical studies identified that under typical conditions, the sinkholes are filled with sediments (USGS, 1967, FDEP 2019). USGS surmised that when local groundwater levels go down under drought conditions, the sediment fill will collapse, allowing the lake to flow into the Floridan Aquifer (USGS, 1967). Other more recent information indicates that Lake Jackson is constantly discharging through Porter Sink. This outflow becomes clear when lake levels are low, and the water can be seen directly draining to the sink. In summer 2021, this condition occurred, and the flow out of the lake to the aquifer was documented in photos and videos. **Photo 4-1** shows the flow entering the area of the Porter Sink from the lake as it drains. **Photo 4-2** shows the Porter sinkhole and the flow moving into the aquifer.

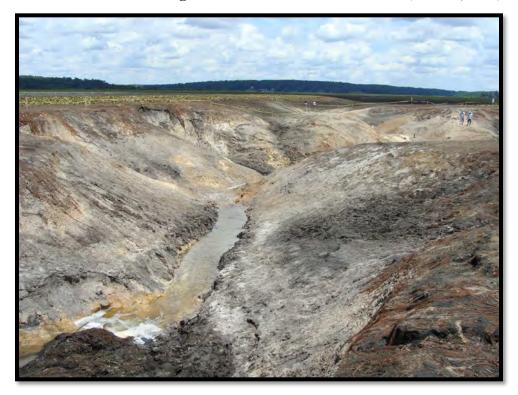
Photo 4-2: Flows Going to Floridan Aquifer through Porter Sink (June 14, 2021)

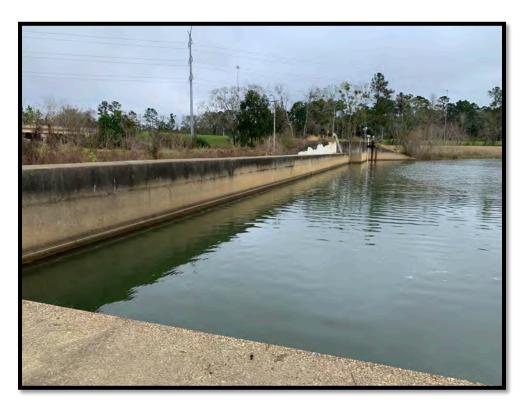
Photo 4-13: MARS Facility Impoundment and Overflow (February 2021)

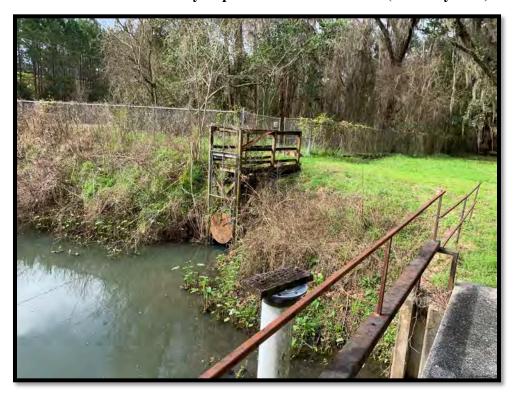
Photo 4-14: MARS Filter Marsh Intake (February 2021)

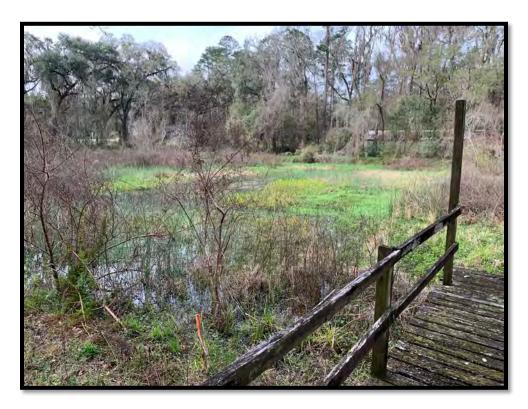
Photo 4-15: MARS Filter Marsh (February 2021)

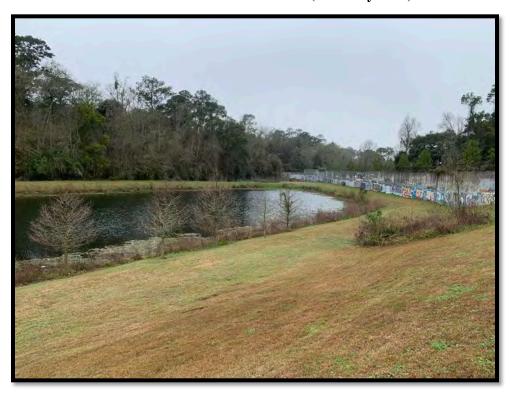
Photo 4-16: Boone Boulevard Pond (February 2021)

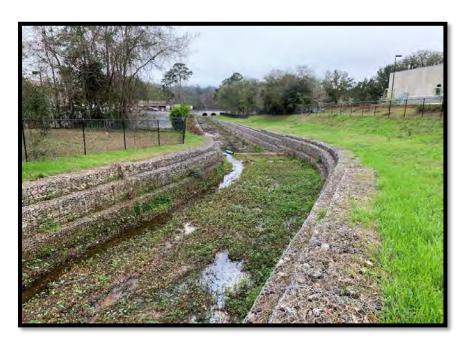
Photo 4-17: Bank Stabilization Along Megginnis Creek
