4.5 Carr Lake

Figure 4-40:
Carr Lake Drainage Basin Overview
Tallahassee Master Plan - Surface
Water (TMaPS)

Volume 4 – Lake Jackson Basin

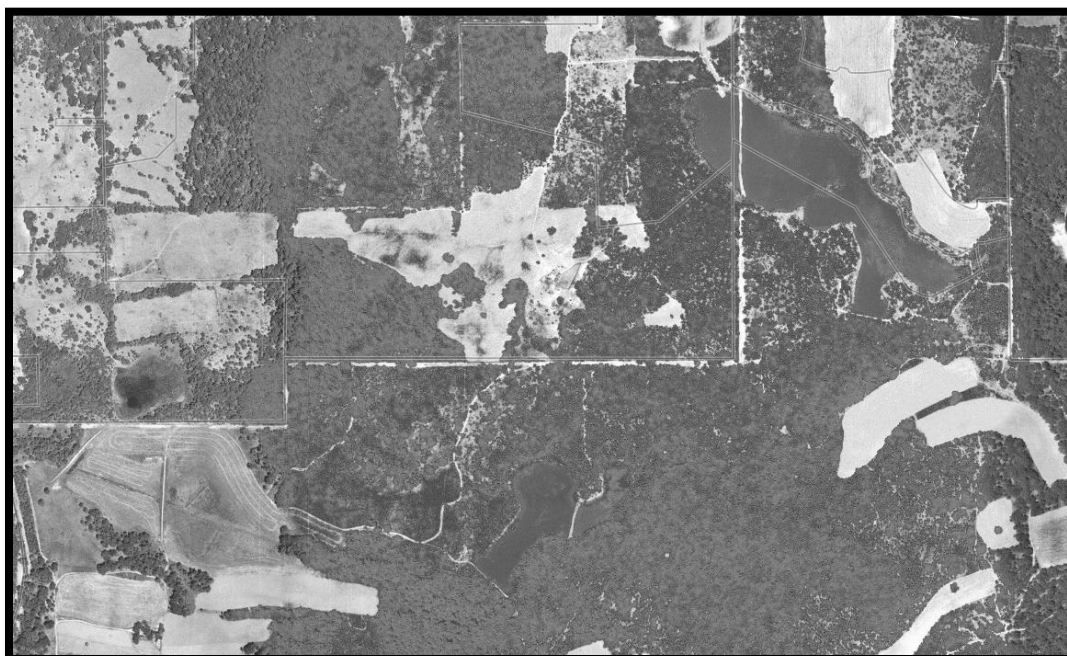
Photo 4-34: Summerbrook Creek Basin Area Aerial (1970)

Photo 4-31 through **Photo 4-38** present aerial views of the Summerbrook Creek basin area from 1937 through the present. In the early aerial views (prior to 1970), the three lakes were not there, but rather, there were small depressional wetland areas that can be seen throughout the basin. Some of the depressional areas line up with the future lake locations. In the 1970 aerial, the footprints of the three lakes can be seen, with Shelly Pond in the process of excavation. In the 1996 aerial, the Summerbrooke subdivision can be seen, along with the footprints of the three lakes.

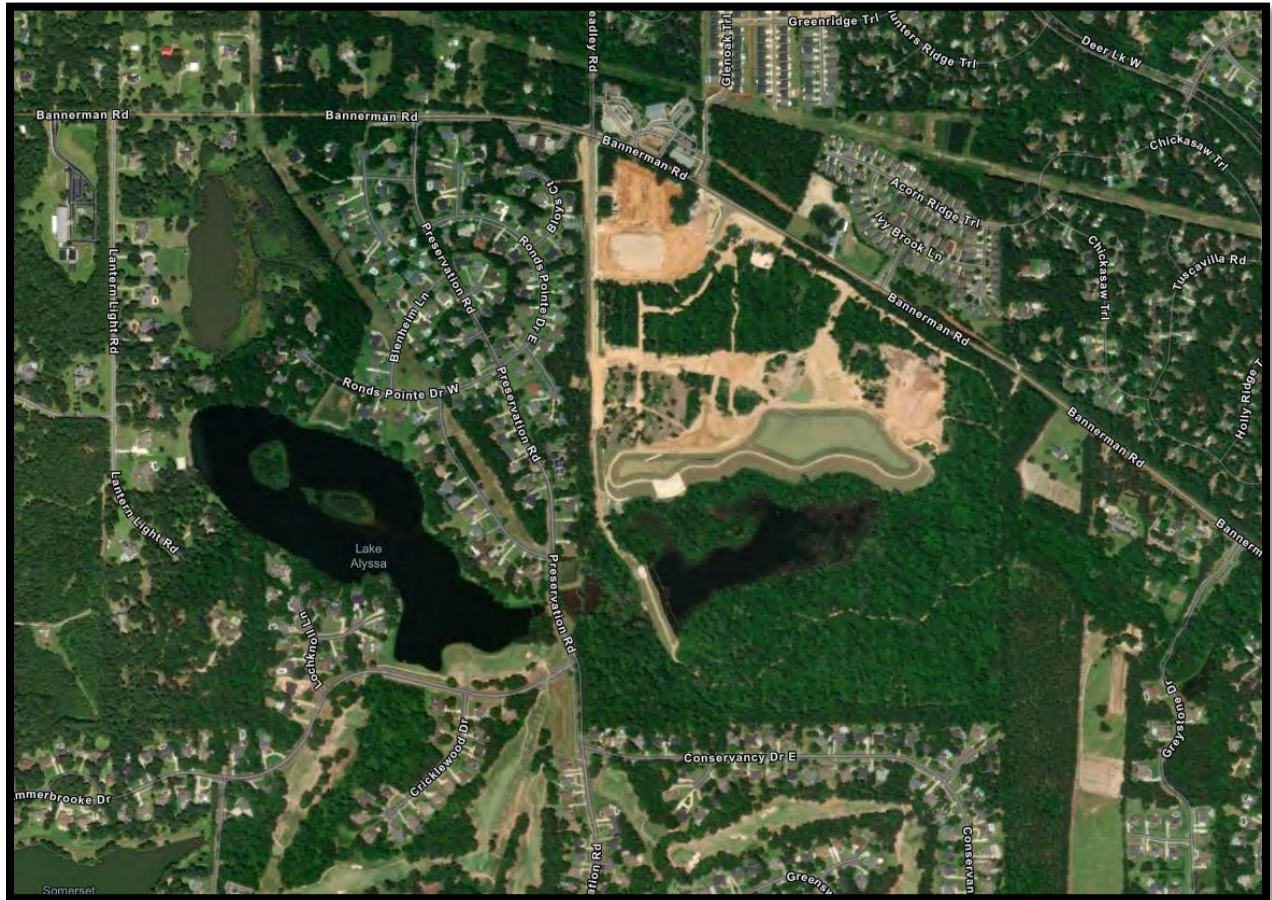
Photo 4-39: Aerial Image of Recent Development within Summerbrook Creek Basin

Figure 4-71 presents a map of the Level 2 land uses within the Summerbrook Creek basin. A table is provided to show the overall acreages and percent cover. Tables are provided for both the Level 2 and grouped Level 1 land uses. The largest land use within the Summerbrook Creek basin, per the grouped Level 1 categories, is Urban and Built Up (57 percent). This is made up primarily of Low Density Residential, with some Medium Density Residential and some Recreational. The Recreational use is primarily associated with the Summerbrooke Golf Course. Per the land use map, which was based on 2019 data, a large area of Upland Forest is in the upper portion of the basin, just south of Bannerman Road. That area is presently undergoing development. **Photo 4-39** presents this area in a recent (2021) aerial image showing cleared areas. This area drains into Lake Alyssa across Preservation Road. In **Photo 4-28a**, the silt curtains presently deployed to reduce sediment load from this project can be seen where the discharge enters Lake Alyssa. The source of the silt was not identified in the review.

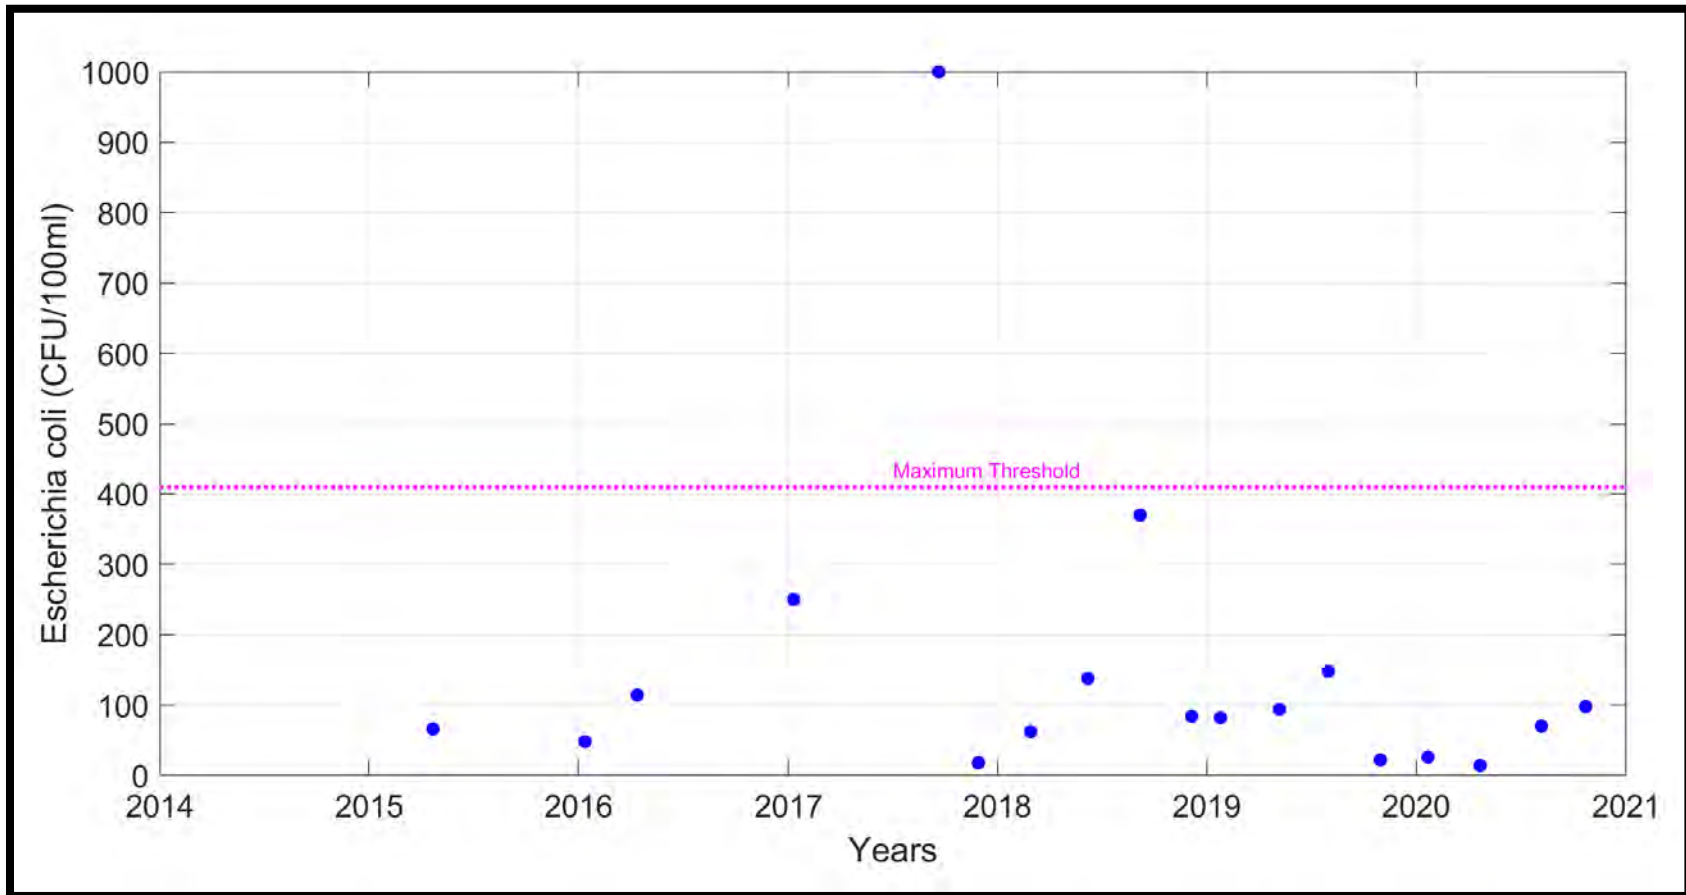
Figure 4-79: Plot of *E. coli* Measurements (2015 to 2020) in Summerbrook Creek

Figure 4-79 presents a plot of the measured *E. coli* from all of the stations from 2010 through 2020. The data are plotted with the 410 MPN/100 mL threshold (described previously) as a dashed line. The data show elevated concentrations with one point above the threshold.

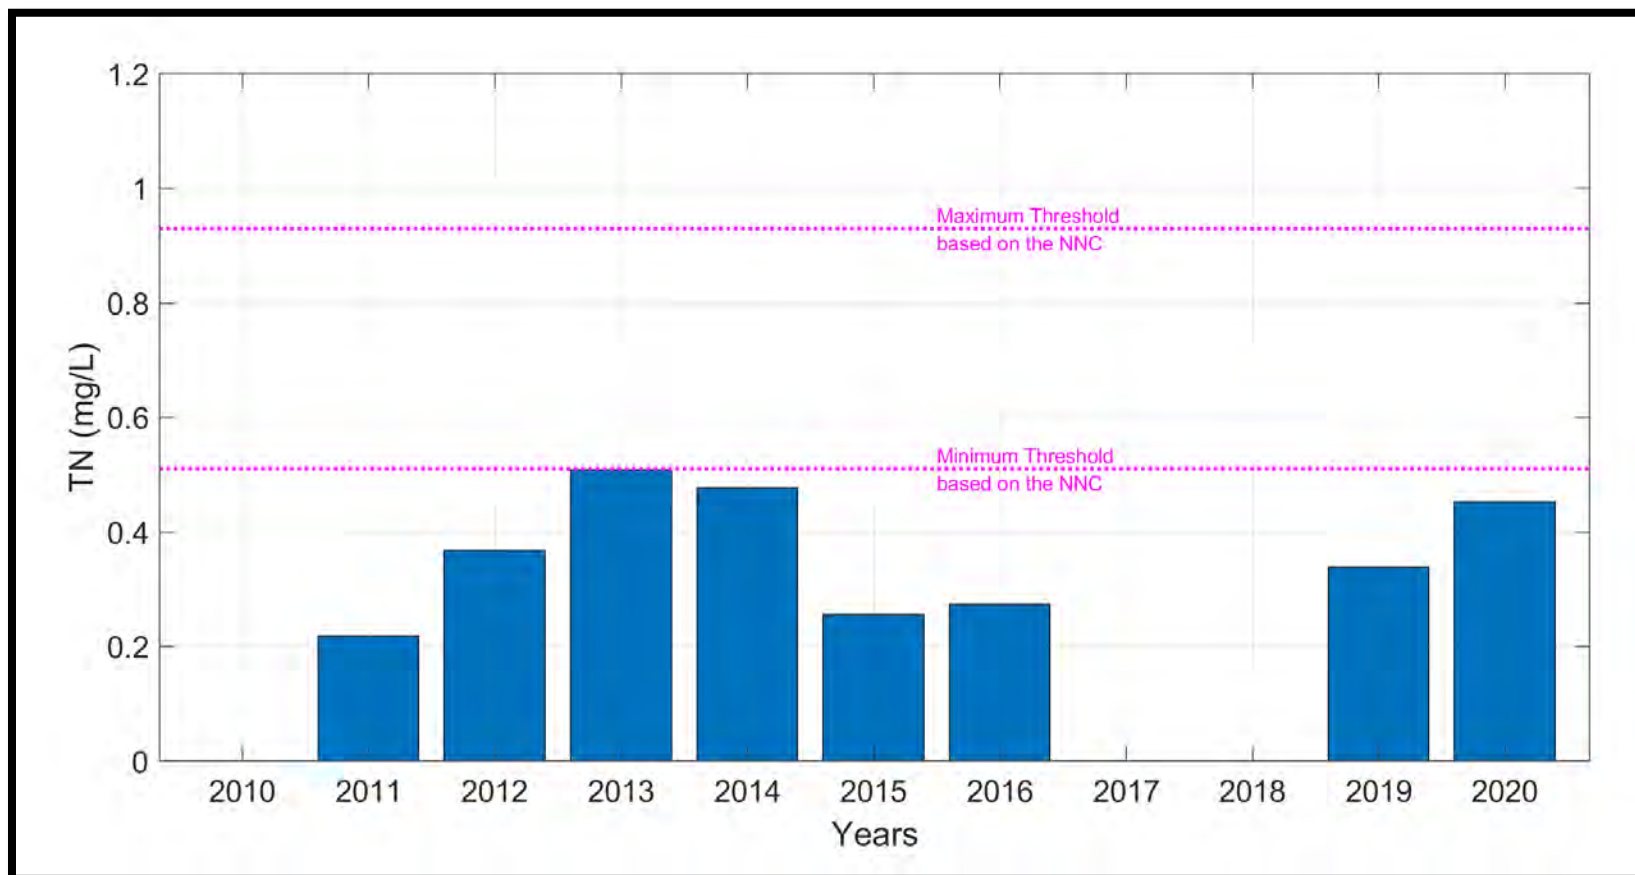
Figure 4-101: Plot of Annual Geometric Means for TN with NNC Criteria for Lake Overstreet

Examination of the TN plot (**Figure 4-101**) shows that from 2010 to 2020 TN AGM levels have been at or below the minimum threshold. The AGMs show a similar rise between 2012 and 2014 that was noted for the raw data.
