4.7.4.3 Septic Systems

**Tallahassee Master Plan - Surface
Water (TMaPS)**

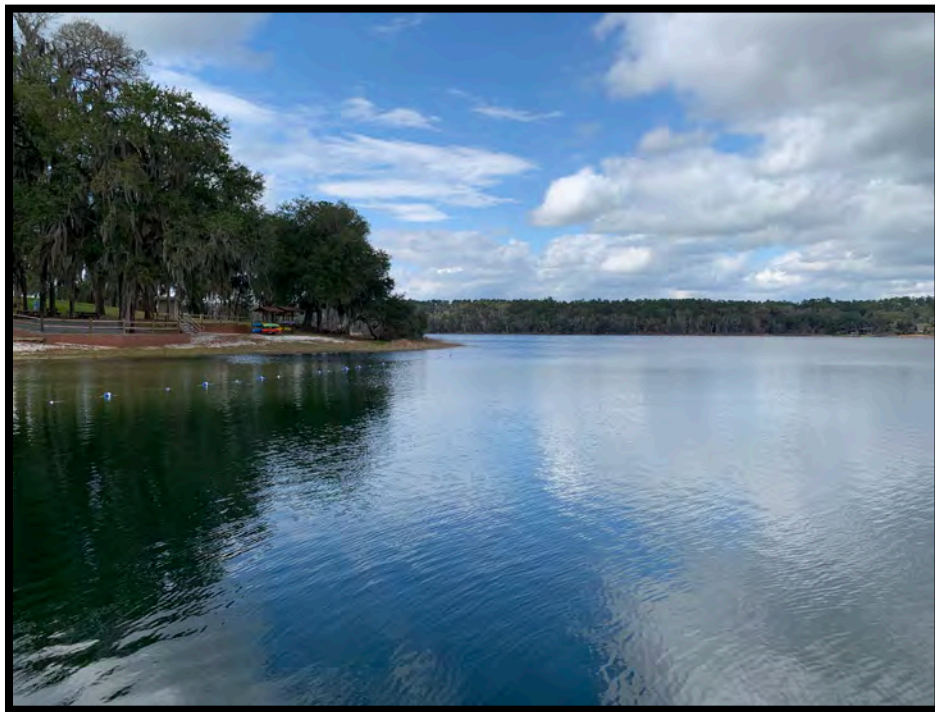
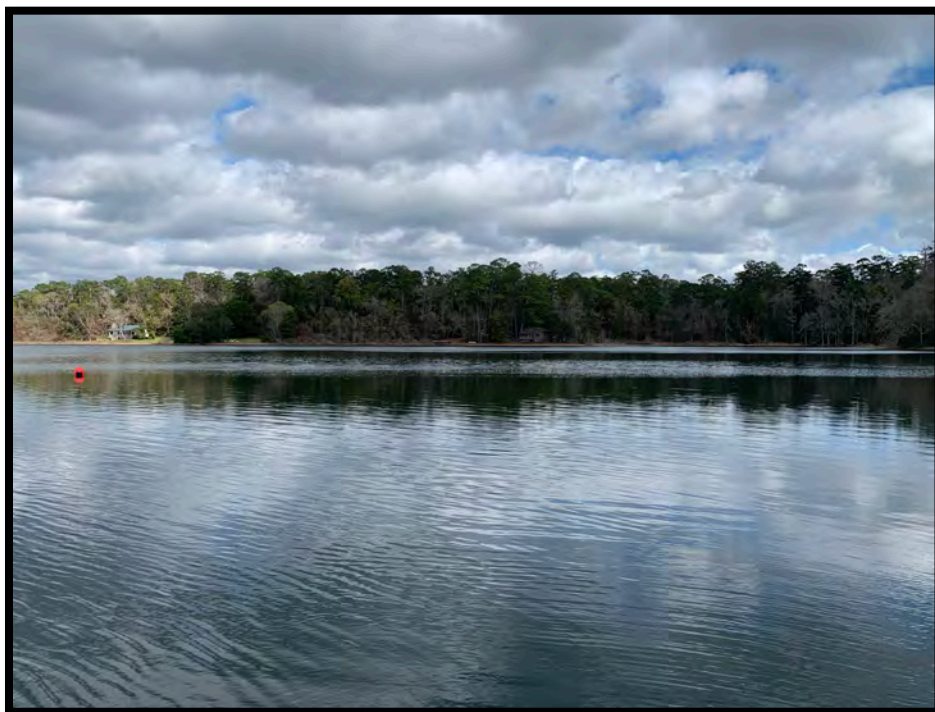
Lake Hall has been identified as one of the most pristine waterbodies in the area. **Photo 4-50** and **Photo 4-51** were taken from the Maclay Gardens boat dock, located in the southern lobe of the lake looking north. The photos show the open water nature of the lake and the general shoreline conditions.

Photo 4-50: Lake Hall Photo 1

Photo 4-51: Lake Hall Photo 2

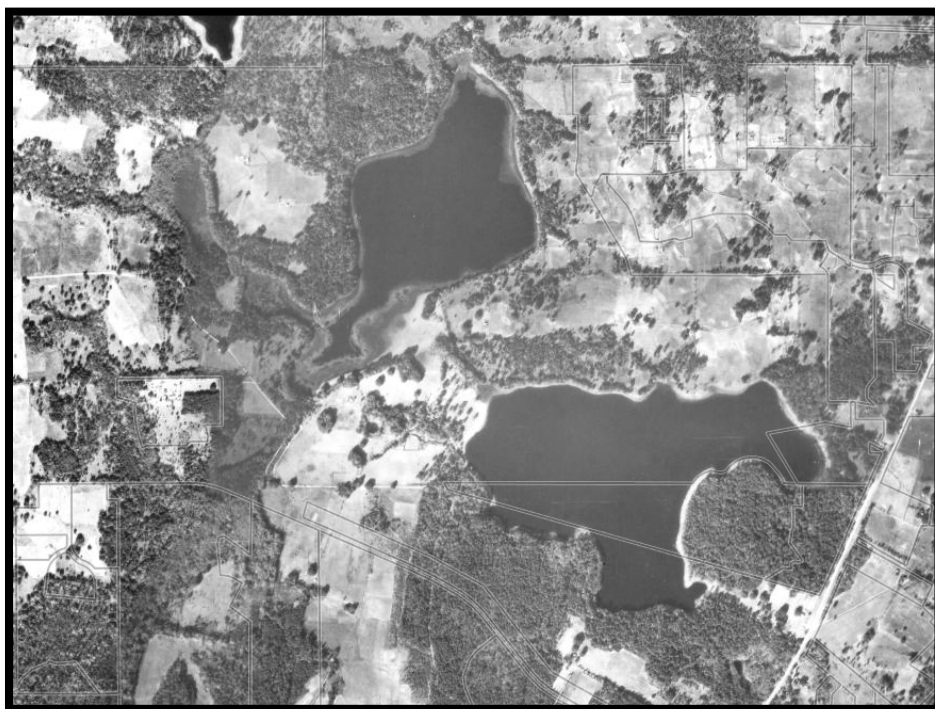
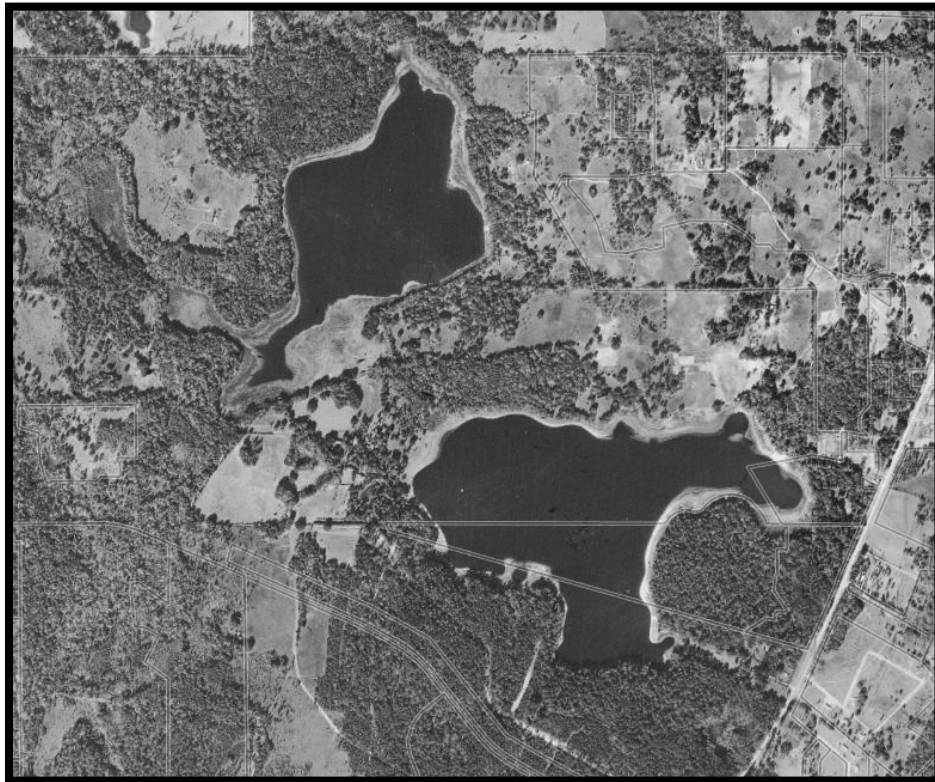
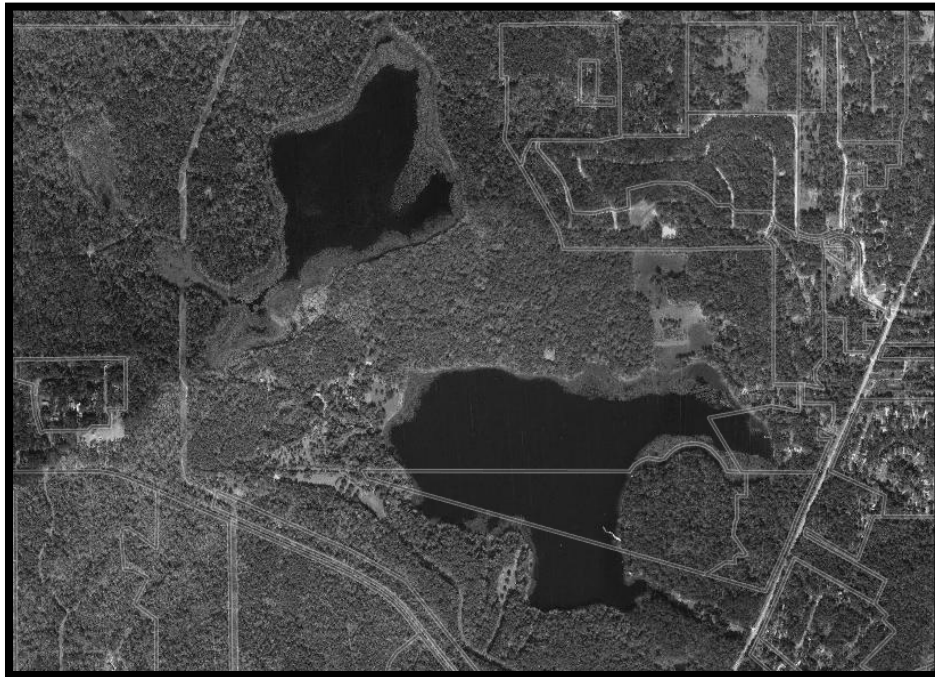
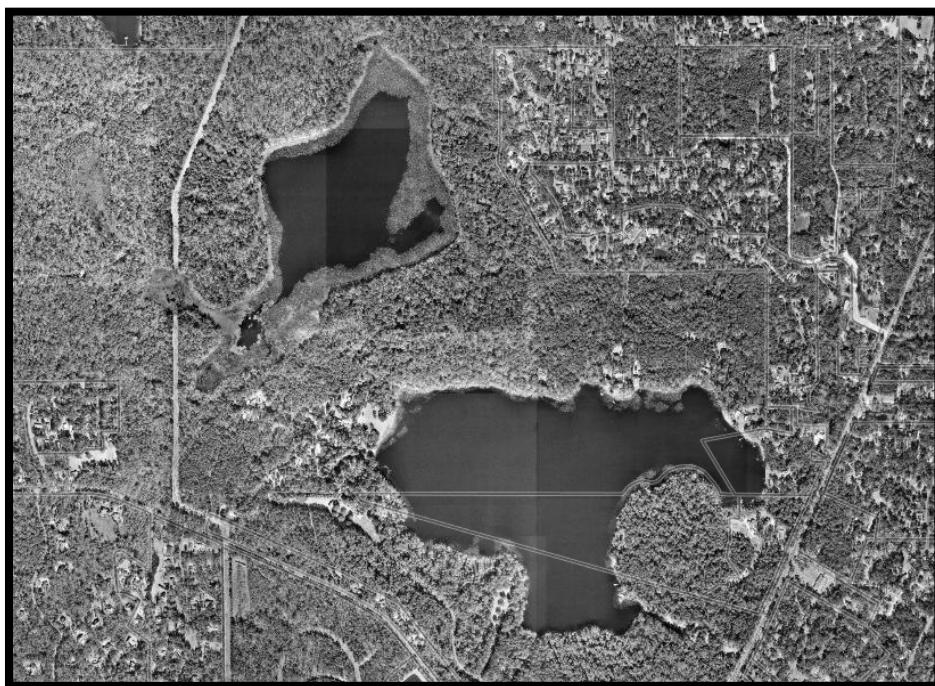
Lake Hall is a deep lake for the area, with maximum depths around 30 ft. **Photo 4-52** through **Photo 4-59** present aerial views of the lake from 1937 through the present. As was seen for Lake Overstreet, the aerial photos show that the lake has generally remained the same over this period of time and, due to the depths, maintains open water throughout much of its area. Prior to 1970, much of the land north of the lake was cleared and was reforested over the years. Lands to the south of the lake have not changed significantly. The residential developments within the closed basin appear over time after around 1970.

Photo 4-52: Lake Hall Aerial (1937)

Photo 4-53: Lake Hall Aerial (1949)

Photo 4-54: Lake Hall Aerial (1954)

Photo 4-55: Lake Hall Aerial (1970)

Photo 4-56: Lake Hall Aerial (1983)

Photo 4-57: Lake Hall Aerial (1996)

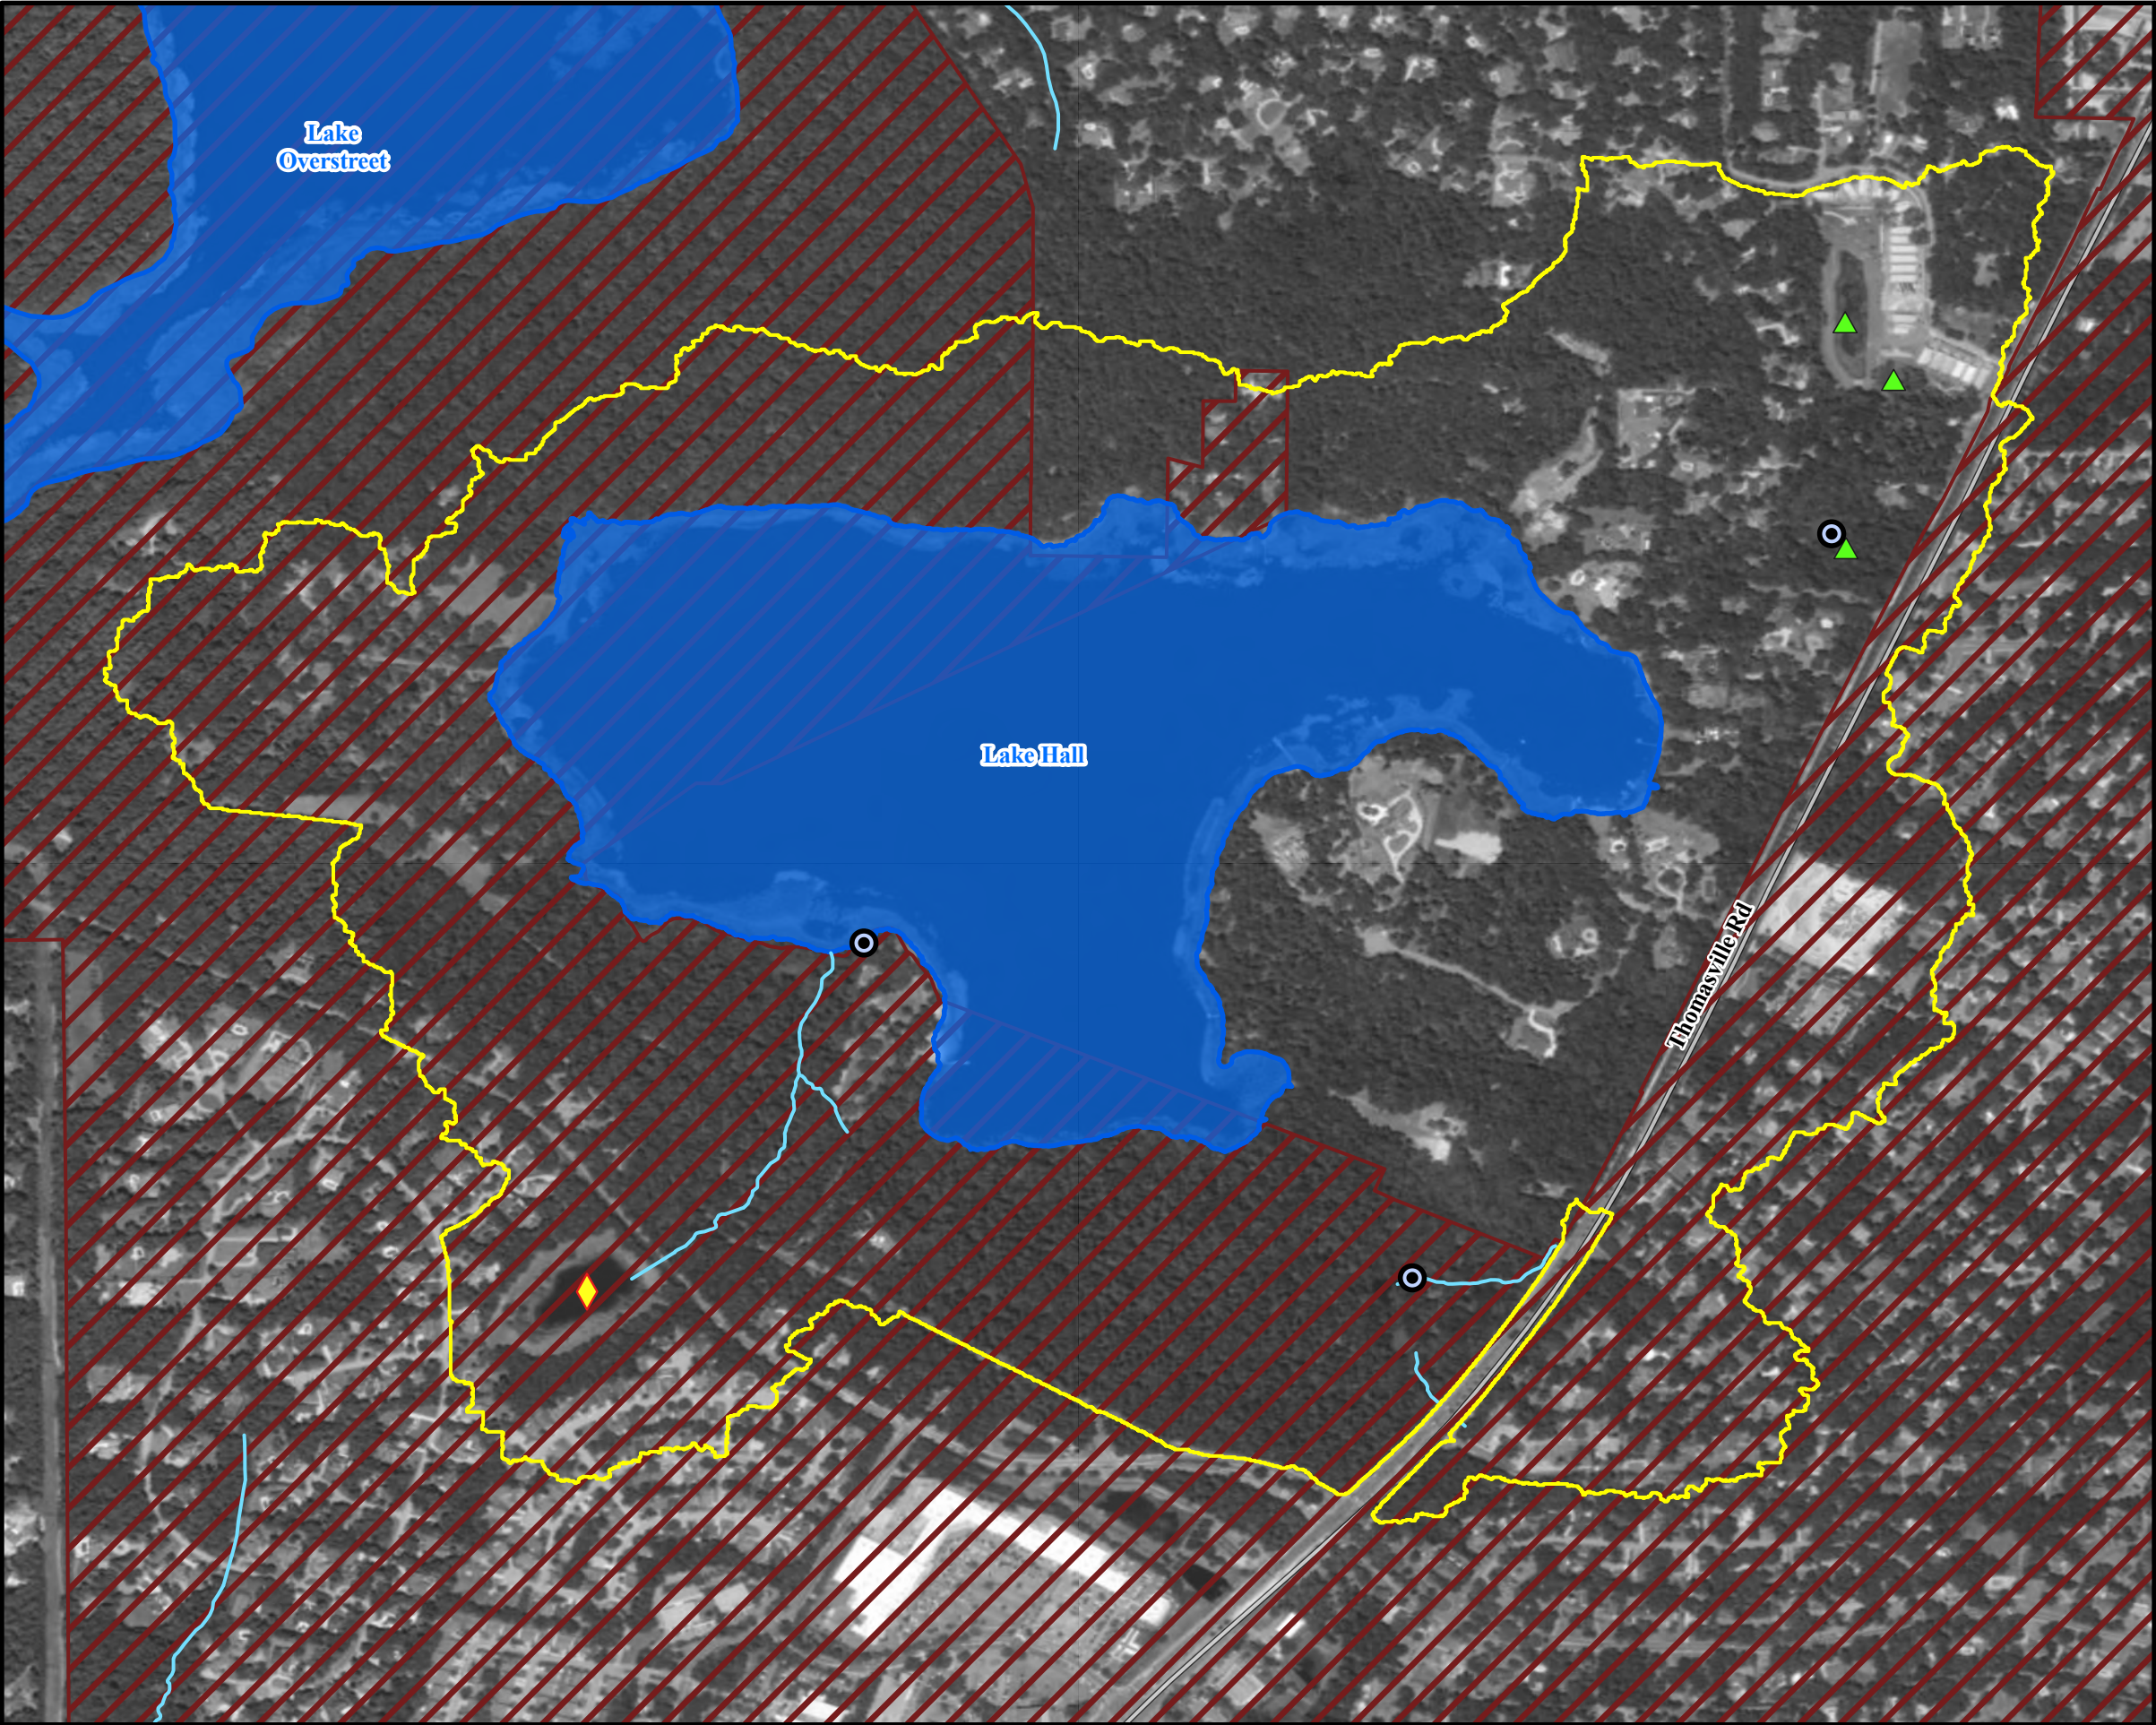
Figure 4-135:
Lake Hall Basin BMP Locations

Figure 4-135 presents a map showing the locations of stormwater treatment facilities throughout the Lake Hall basin. There are relatively few facilities throughout the basin, and these are located within the neighborhoods along Thomasville Road and Maclay Road. The facilities are maintained by the City, Leon County, and Maclay Gardens. No facilities are located within the portion of the basin within neighborhoods east of Thomasville Road.
