# Controlling Hydrilla at Wakulla Springs State Park (1997-2007)

Jess Van Dyke, DEP's Northwest Florida Regional Biologist (retired)

March 19, 2019

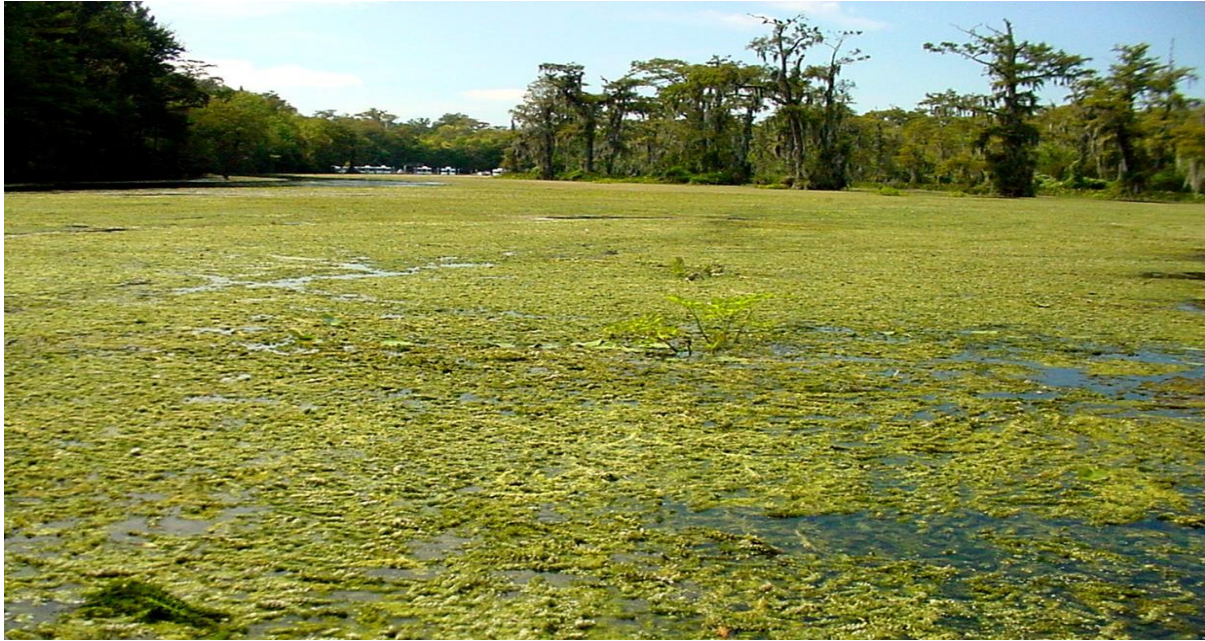
Looking east toward the boat dock, hydrilla mats smother the upper Wakulla River in 2001 (JVD)

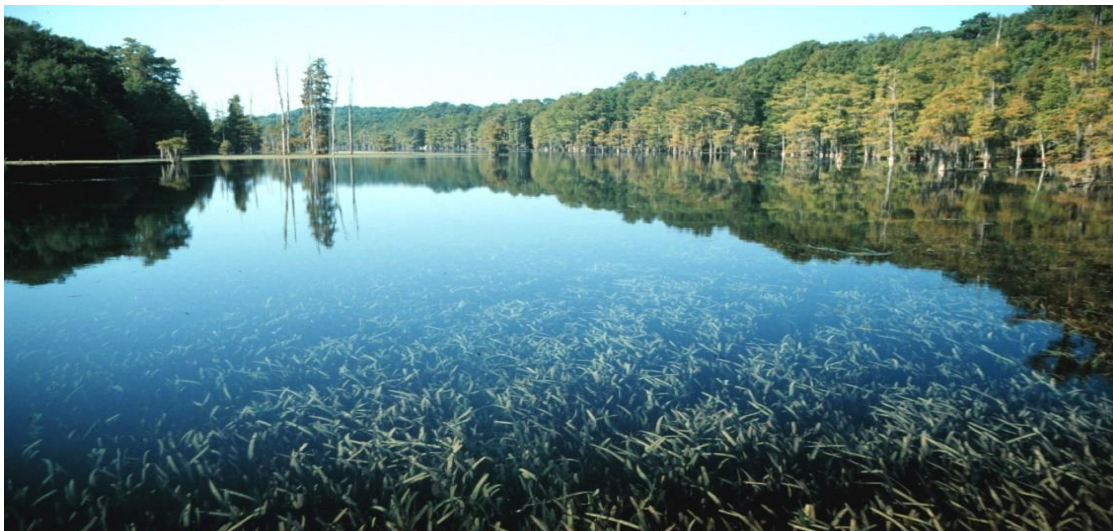
In 1999, hydrilla declined while *Vallisneria* rebounded in Merritt's Mill Pond post treatment (JVD).

Meanwhile, a confluence of research findings provided the first hope of controlling hydrilla in flowing water. Dr. Mike Netherland's laboratory results at the USACOE on concentrations and exposures times with Aquathol K (40.3% endothall) indicated that concentrations of 2 ppm ae/48hr would reduce hydrilla biomass by 85%. Eurasian Watermilfoil (*Myriophyllum spicatum*), a big problem in the lower Wakulla River at that time, required only 0.5 ppm ae/48 hr. Meanwhile near Marianna, Florida, hydrilla had infested an impounded spring run, called Merritt's Mill Pond (202 acres). After treating the upstream part of the system on two consecutive days, it became clear that a 48-hour contact time provided excellent system-wide results with effective hydrilla control miles downstream. In time, hydrilla was greatly reduced there while its major competitor, *Vallisneria americana*, expanded. I presented the idea of using Aquathol in Wakulla Springs to park manager, Sandy Cook, and park biologist, Scott Savery, by giving them a tour of Merritt's Mill Pond. They were suitably impressed.

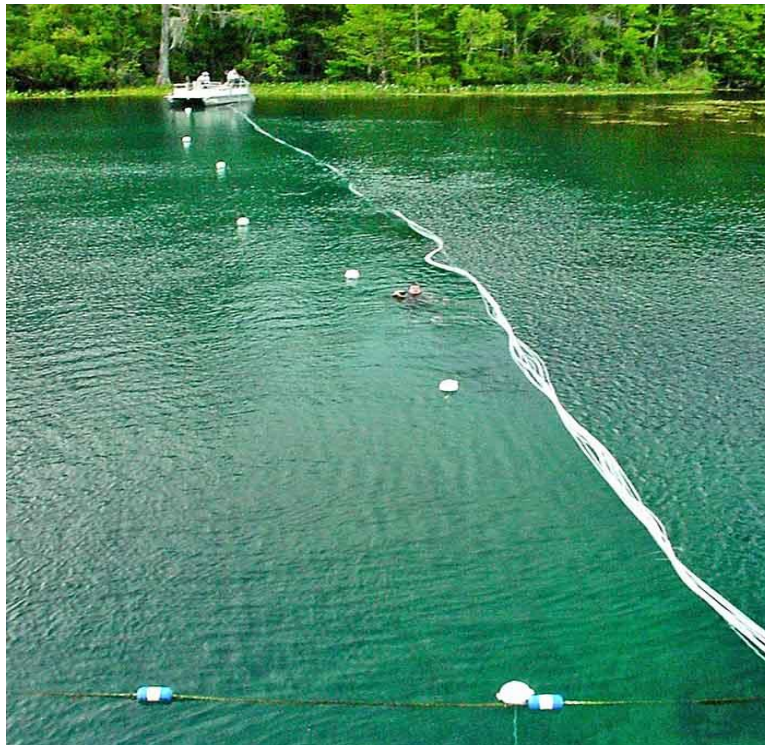
A key question remained: How would it be possible to maintain the necessary concentration of Aquathol for two days in a larger flowing system like the Wakulla River? Fortunately, the answer had been recently developed for herbicide applications in irrigation canals, called a “drip system.” On a barge next to the park’s diving dock, Terry McNabb of AquaTechnex constructed a simple delivery system for flowing water. Using a 12-volt pump, manifold, regulating orifices, and 10 hoses, Aquathol could be evenly applied at the desired rate over time to the headwaters of the Wakulla River.

In response to a request from the Park Manager, DEP's Bureau of Invasive Plant Management conducted the first hydrilla treatment in Wakulla Springs on April 15-17, 2002. Over a 52-hour period, 1750 gallons of Aquathol K was applied via ten hoses with outlets evenly-spaced across the entire basin. The flow rate at the time was measured at 145 cfs, so the maximum calculated concentration was 4.24 ppm ae. Water sampling during the treatment revealed that the actual concentrations were 1.75 ppm at the dock, 4.10 ppm at the "First turn," 4.13 ppm at "The Ways," 2.14 at "The Osprey Nest," 0.70 ppm at the end of the "Back Jungle," and 1.05 ppm at the CR 365 Bridge. Shortly after this initial application, profound changes occurred in the Wakulla River.

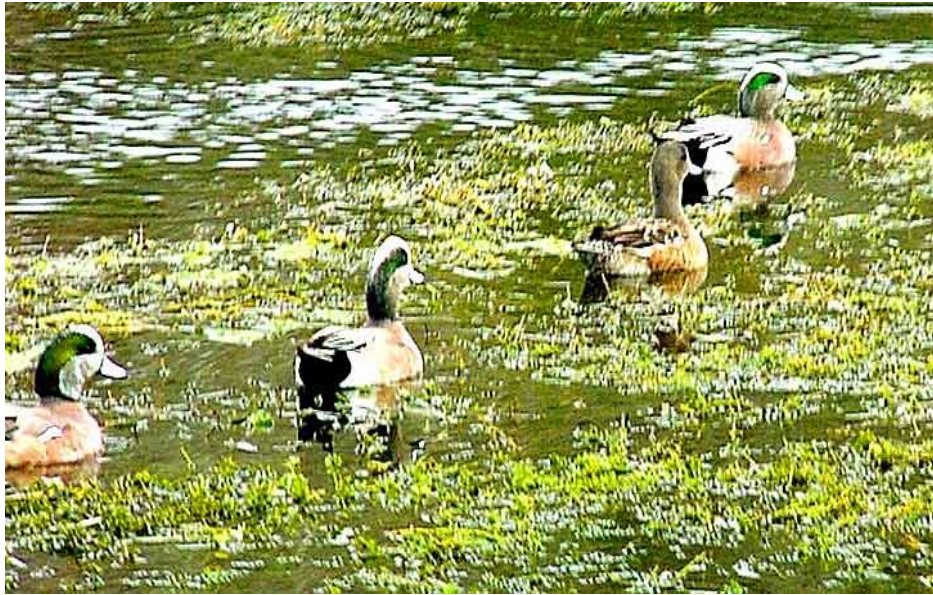
Wintering American Wigeons on a hydrilla mat at Wakulla Springs in 2001 (JVD).

There is no question that surface mats of hydrilla attract wildlife, especially herbivorous dabbling ducks, such as the American Wigeon (*Mareca americana*). Since hydrilla was effectively controlled, the historically large, wintering widgeon population at Wakulla Springs dramatically declined. Now, these ducks are only “periodically observed in very low numbers.” Based on Bob Thompson’s 20-year summary of wildlife monitoring observations (1997-2016), only three animal species have increased during that period, while the average sightings of twelve have declined. Keep in mind that the quantitatively monitoring of mobile wildlife is difficult; hydrilla mats may have improved visual detection of wildlife; and linking all of wildlife changes to hydrilla control is a stretch given the myriad of factors affecting their numbers and distribution. For instance, a similar decline in widgeons was noted in the St. Marks Wildlife Refuge at that time. However, the extensive physical and biological changes to wildlife habitat in Wakulla Springs subsequent to hydrilla treatment cannot be denied.

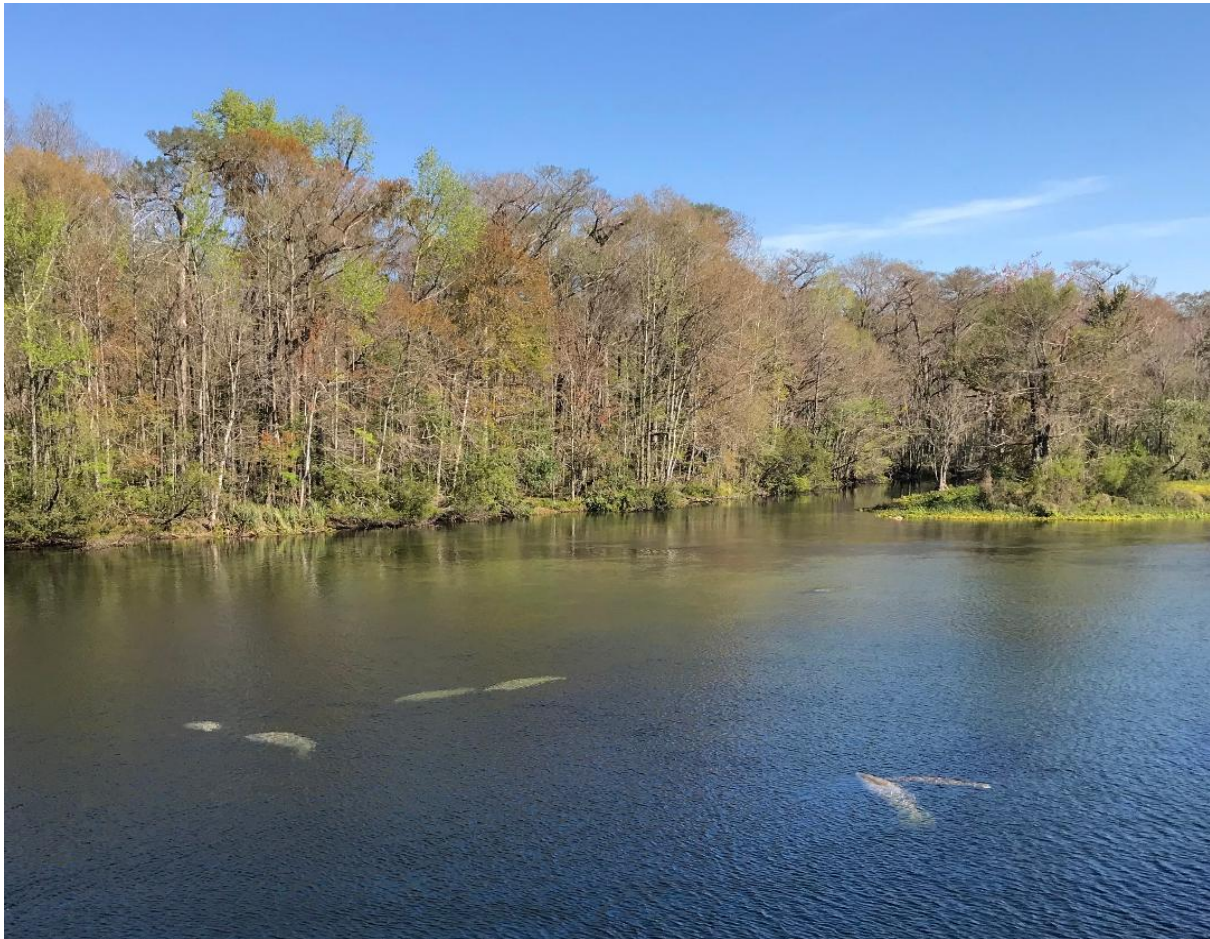
Sixteen Florida manatees (*Trichechus manatus latirostris*) were observed on March 7, 2019 (JVD)

What changed in the Wakulla River to facilitate movement of manatees into the park after the hydrilla treatment in 2002? As mentioned previously, the rapid decline in hydrilla biomass resulted in sufficient flow velocity to scour channels through accumulated organic sediments. Regarding manatee access, a crucial channel was created just north of the CR 365 Bridge. Prior to the treatment, this area was shallow, occupied by a dense stand of hydrilla, and impassable. After treatment, a channel was created that was sufficient for manatee to gain access to the park, and it remains to this day.

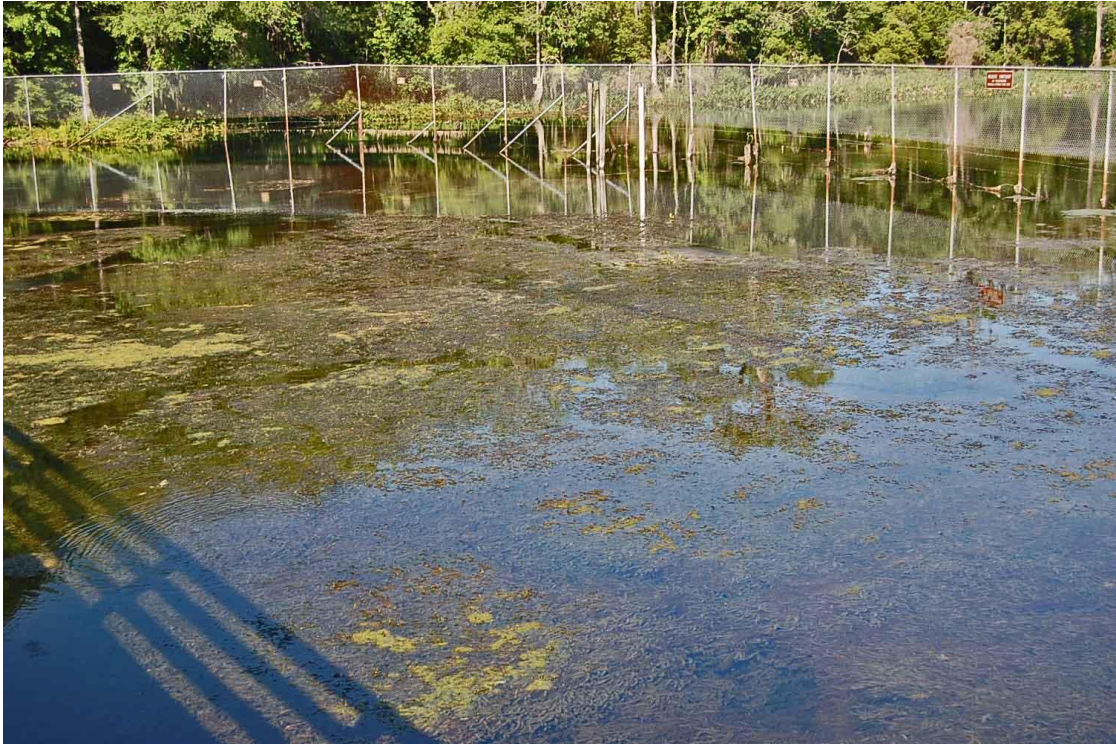
North of the CR 365 Bridge, dense vegetation formed an impassable barrier to manatees in 2001 (JVD).

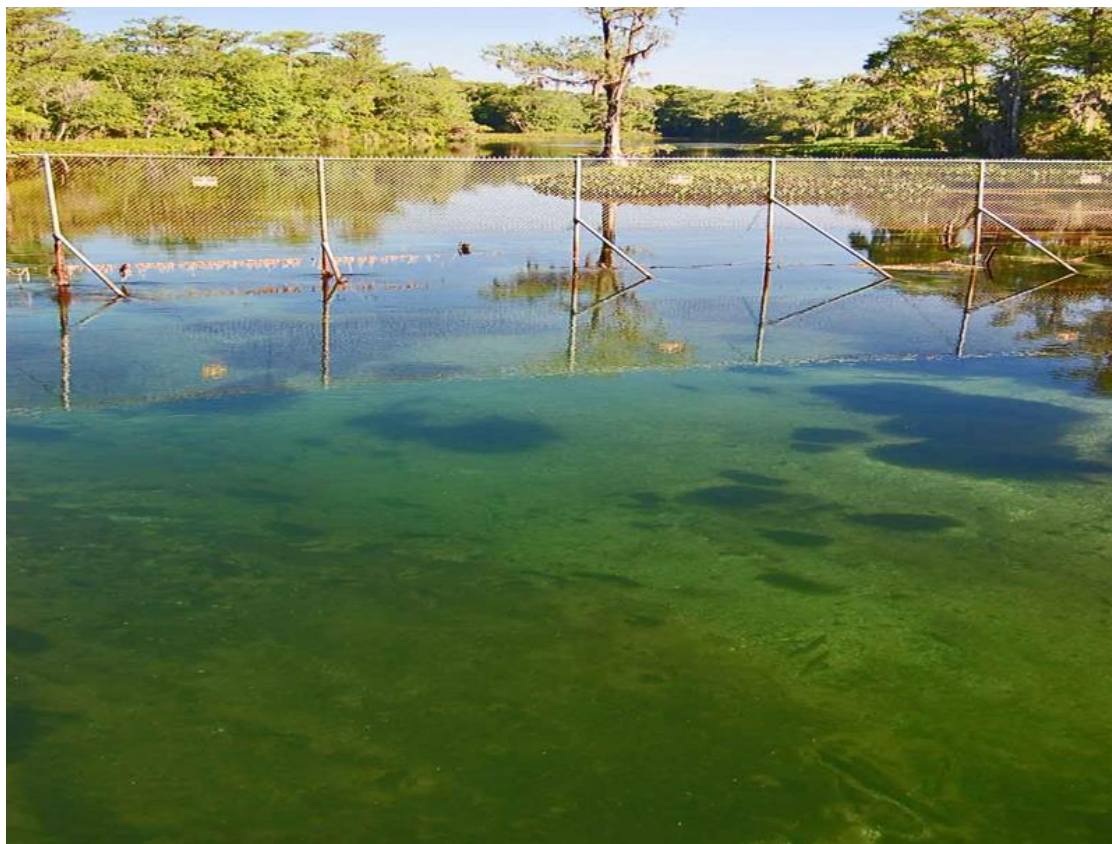
The treatment in 2002 created a channel sufficient for manatee access to the park (JVD).

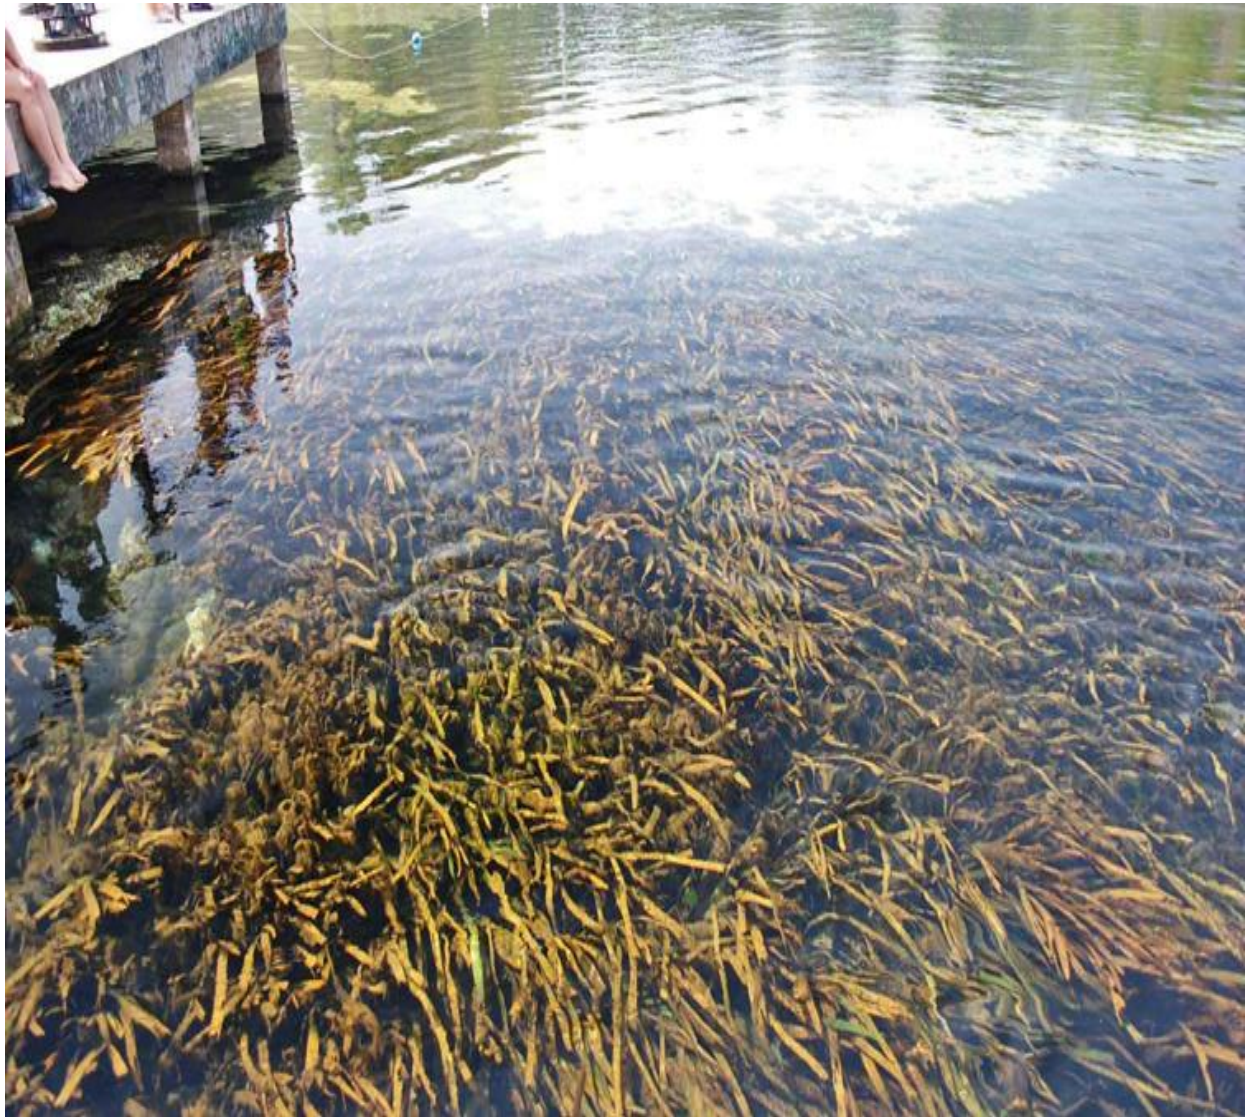
Dense stand of *Vallisneria* adjacent to the boat dock in 2006 (JVD).

Hydrilla is a fierce competitor. One hydrilla plant is the complete equivalent to over seven *Vallisneria* plants. When rooted together in nutrient-rich substrates, hydrilla grows three times faster than *Vallisneria*. Add to that hydrilla's propensity to form light-blocking canopies, and there is little wonder why *Vallisneria* lost its traditional dominance in the upper Wakulla River subsequent to the exotic invasion. One year after the initial herbicide treatment, much of the bottom exposed due to sediment scouring and the absence of the hydrilla. Biologist seized the opportunity by augmenting the expansion of herbicide-resistant *Vallisneria*. In 2004, two-hundred-and-six *Vallisneria* plants were transported from Merritt's Millpond and planted near the boat dock. This vegetated area has expanded and is still obvious today. Other efforts followed, however, the expansion of native submersed plants in the upper river has been gradual in the absence of hydrilla. More planting efforts may be warranted.

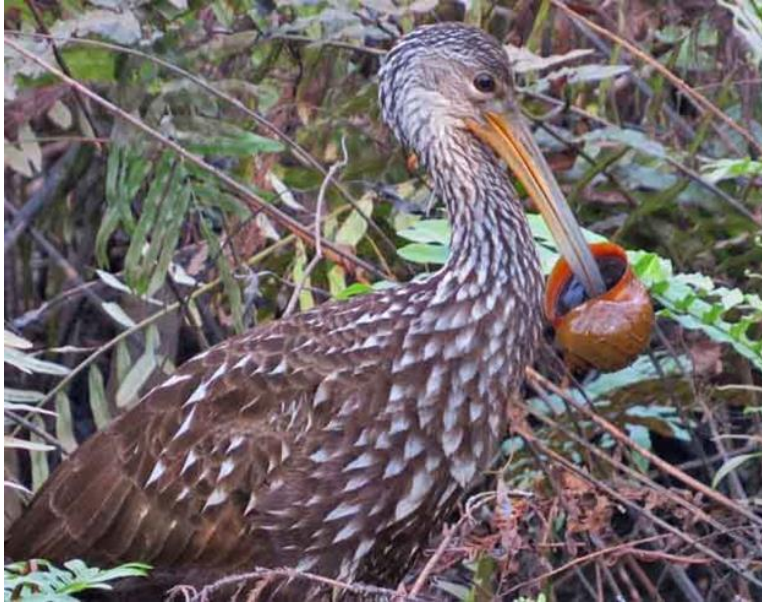
A limpkin prepares to dine on a Florida applesnail (Tom Obrock).

Perhaps because of its haunting cry, the disappearance of Wakulla Spring's avian trademark, the Limpkin (*Aramus guarauna*), has been particularly disappointing. In 1971, seventy-one of these birds were in residence. In 2000, prior to any herbicide treatments, there were none. That loss mirrored a decline of the Limpkin's preferred food item, the Florida Applesnail (*Pomacea paludosa*). In an effort to spur a return of the Limpkin, snail eggs were collected from the Wacissa River. To avoid predation, juvenile snails were reared in a controlled environment to 2 cm in size. Almost 3,000 were transported to the park from 2003 to 2007. The response has been muted based on egg counts, but there is always hope for a rebound of the applesnails and a return of the Limpkin to Wakulla Springs State Park.

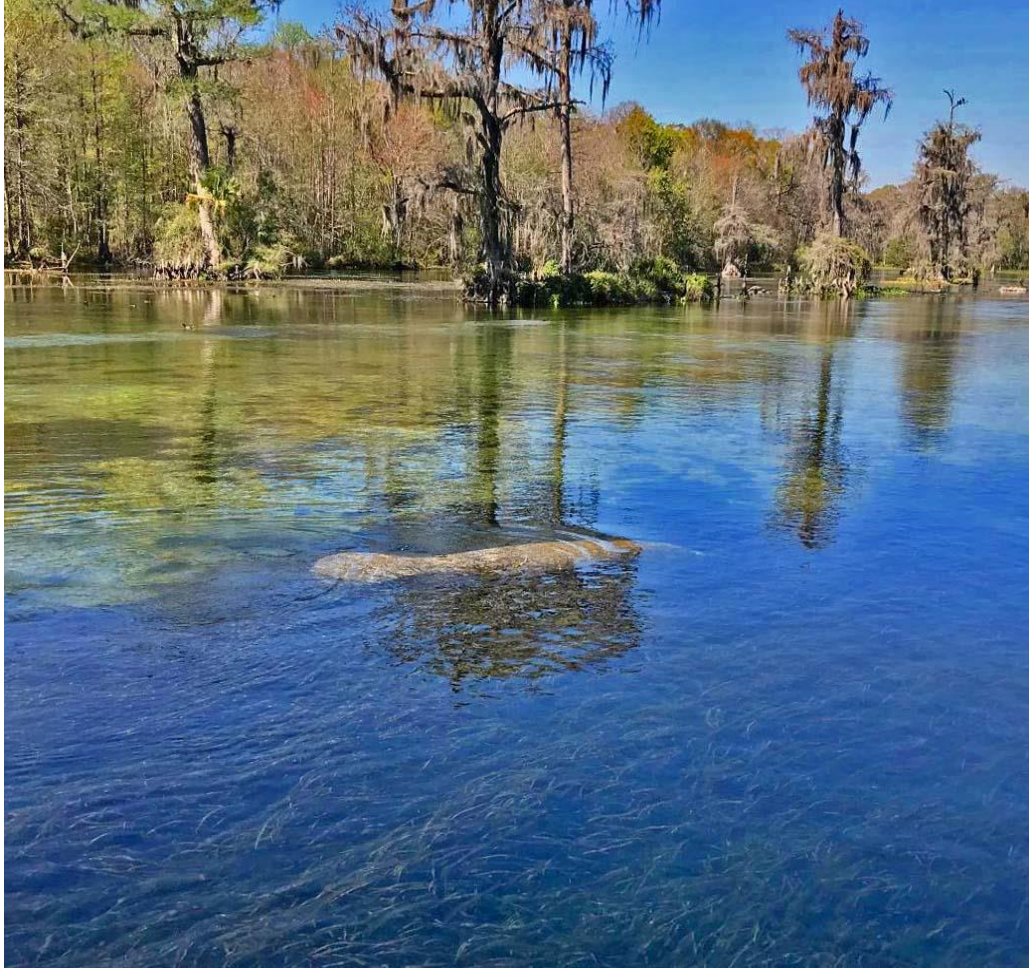
A manatee grazing on a bed of Strap-leaf Sagittaria at Wakulla Springs on March 7, 2018 (JVD).
